LOCAL LIST ADDITIONS & ARTICLE 4 DIRECTON PROPOSALS
ST ANTHONY AND OUR LADY OF MERCY CATHOLIC CHURCH

ST ANTHONY & OUR LADY OF MERCY
LOCATIONS OF KNOWN/VISIBLE DEFECTS.

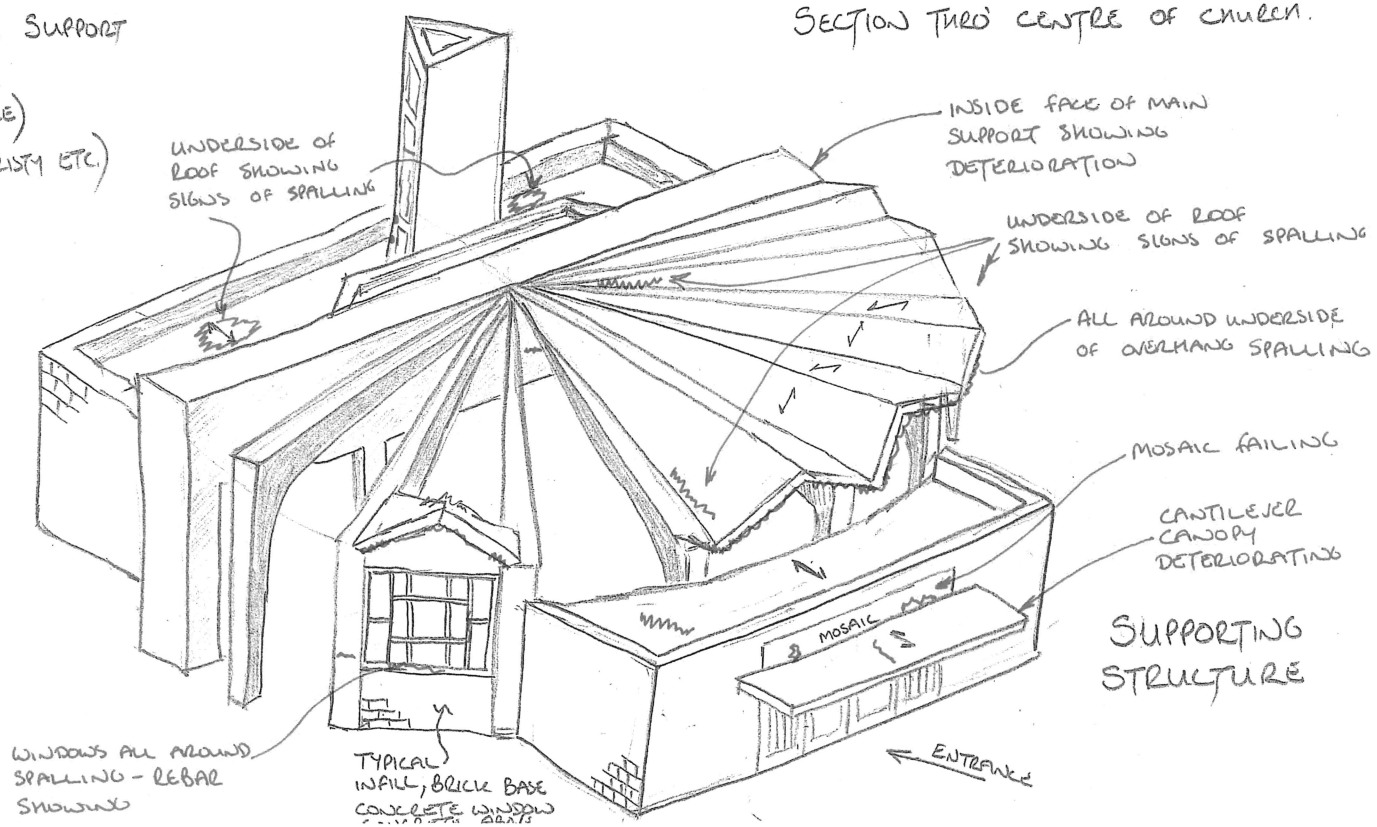
ii. The lifespan of the church is very time limited. As per many other 1960s reinforced concrete structures, it was built with insufficient concrete cover on the reinforcing bars. As a consequence, the reinforcing bars are corroding and the concrete spalling. Whilst repairs can be made to an extent, the mechanism of the corrosion cannot be stopped and the structure will continue to deteriorate unseen. There may come a point in time that we need to be in a position to demolish the building quickly to prevent a structural collapse.

1985
SKYLIGHTS LEAKING
CONCRETE SPALLING ON EXTERNAL FACES OF SUPPORT TOWER
UNDERSIDE OF ROOF SHOWING SIGNS OF SPALLING
UNDERSIDE OF ROOF SHOWING SIGNS OF SPALLING
CONCRETE SPALLING ON EXTERNAL FACE OF MAIN SUPPORT STRUCTURE
INSIDE FACE OF WALL SHOWING SIGNS OF DETERIORATION
CONCRETE WINDOW FRAMES SPALLING
SHOWING SIGNS OF SPALLING
CONCRETE SPALLING ON UNDERSIDE OF OVER HANG - COMPLETE PERIMETER OF FAN SHAPED ROOF
ENTRANCE
CANTILEVER CANOPY DETERIORATING
Imagery Date: 9/13/2022 53°46'28.06" N 0°21'26.04" W elev 0 m eye alt 59 m
Google Earth
